SFB-related Accelerator R&D at ELSA

SFB Mitgliederversammlung

19.03.2013, Bonn

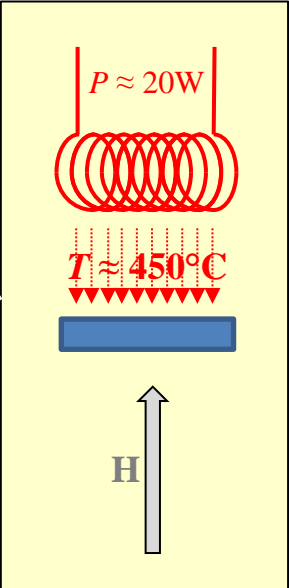
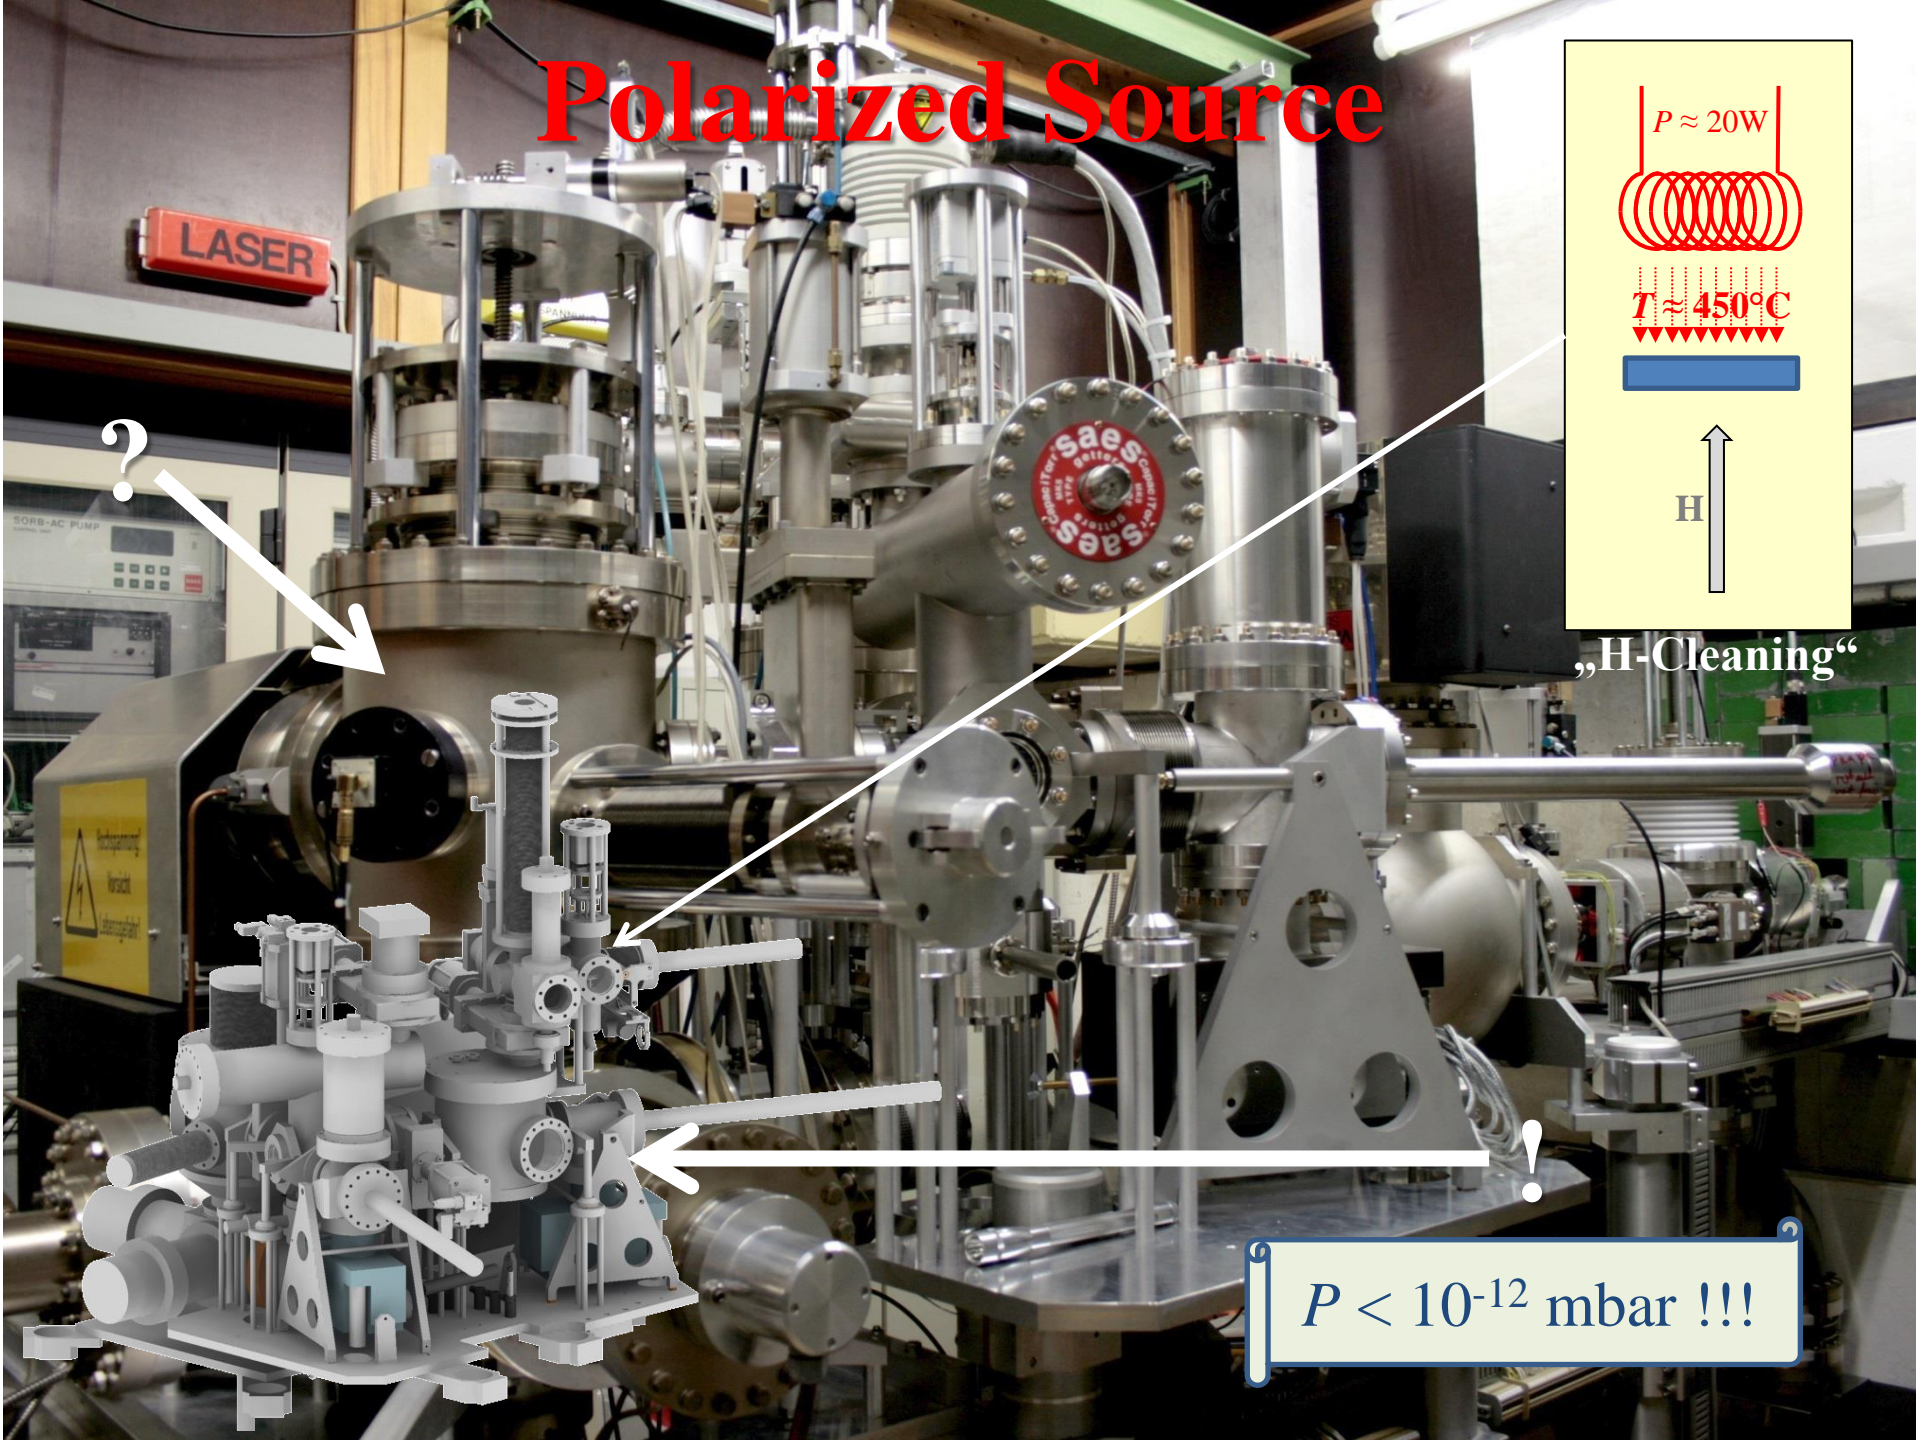
Polarized Source

„H-Cleaning“

$P < 10^{-12}$ mbar !!!

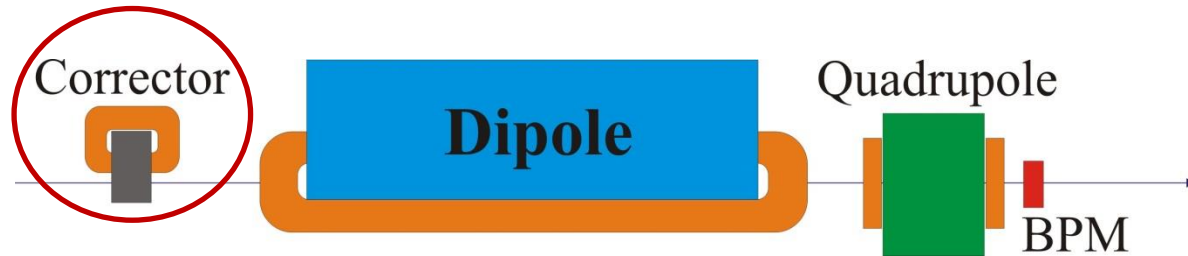
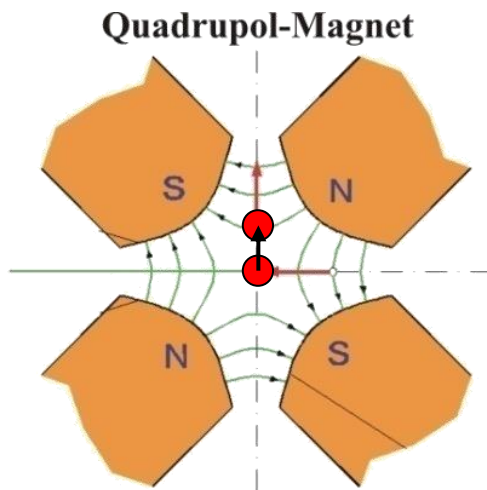
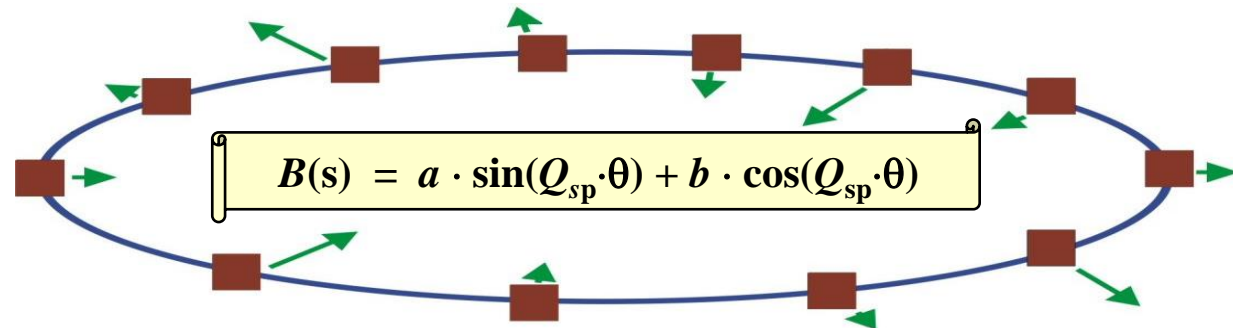
Improved Harmonic Correction

Take care of the orbit distortions caused by harmcor!

New (more sophisticated) method:

Use of a Spin-Response-Matrix to determine the required corrector fields:

$$b_{\text{harm}} = \mathbf{M} \cdot (\mathbf{I} + \mathbf{g} \cdot \mathbf{R}) \cdot b_{\text{cor}}$$

Due to partial cancellation significantly higher fields and a faster time response are required!

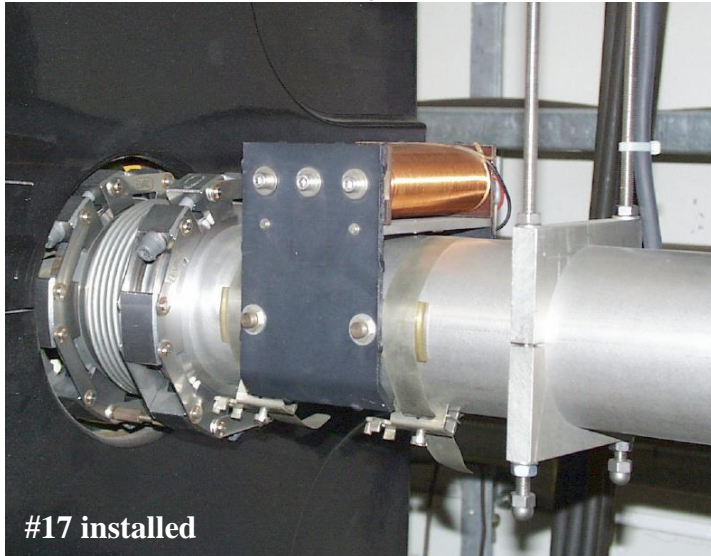
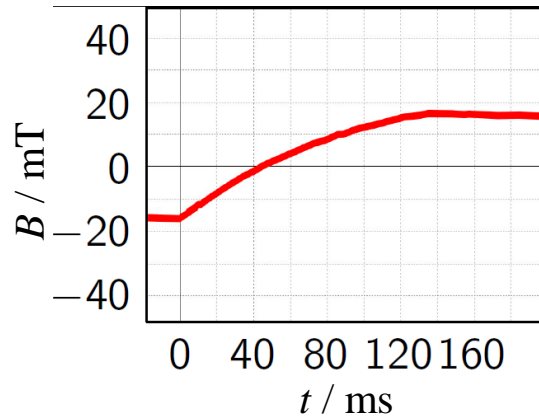
Old System

rise-time
of
magn. field:

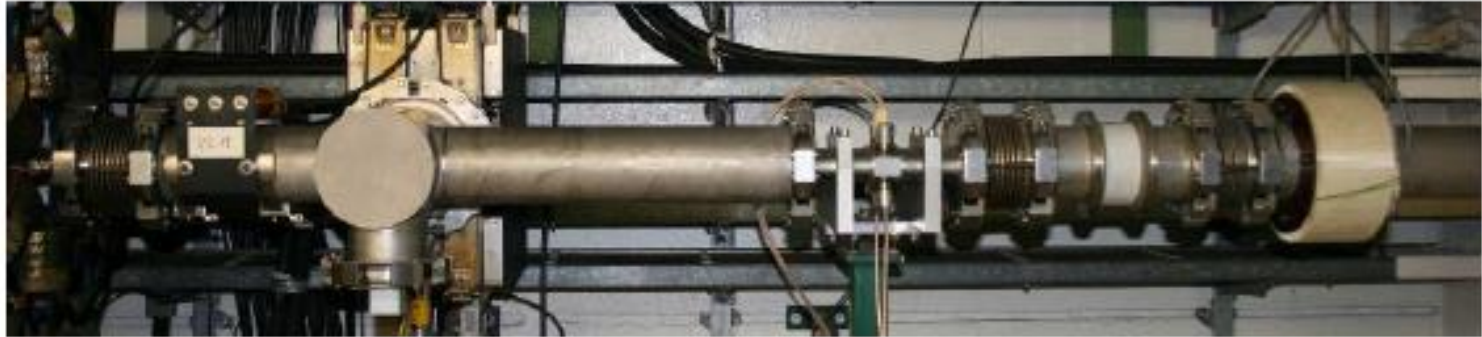
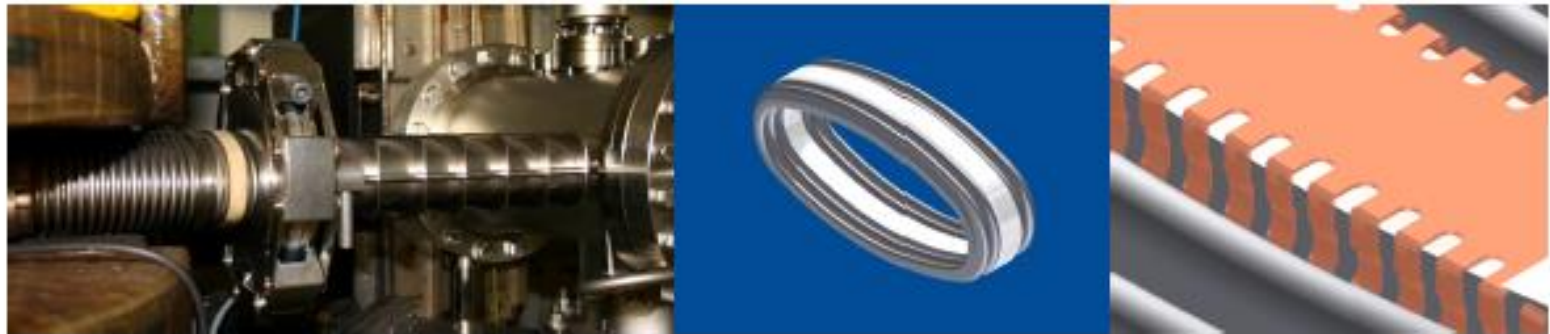
Impedance Reduction

- **installation of new IGP crosses with elliptical geometry**
- **bridging of ceramic brakes (x48) in the dipole chambers**
($\approx 1 \text{ M}\Omega$ contribution to impedance of beam pipe!)

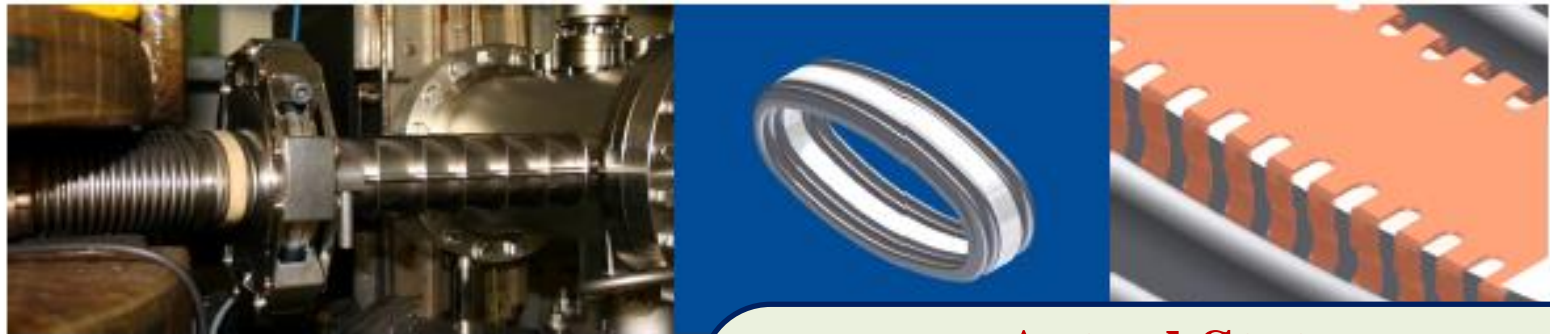
Impedance Reduction

- installation of new IGP
- bridging of ceramic bra
($\approx 1 \text{ M}\Omega$ contribution to

Actual Status:

- design work ongoing on dedicated components
- complete venting of ELSA required for installation!
→ longer ELSA shut-down required!

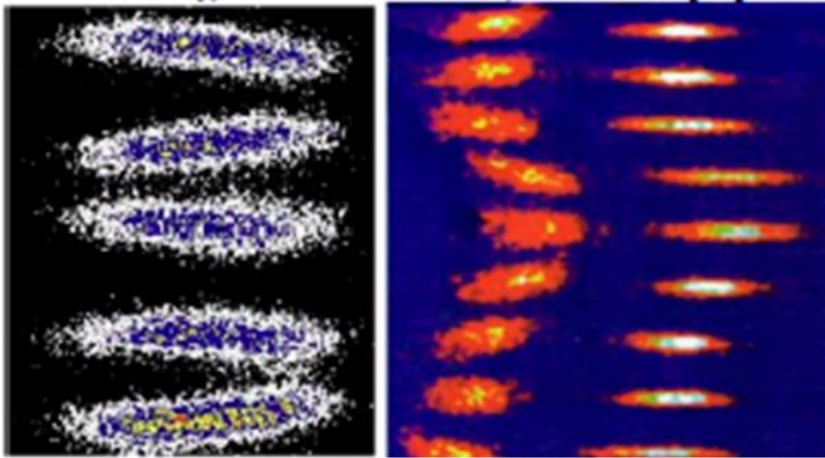
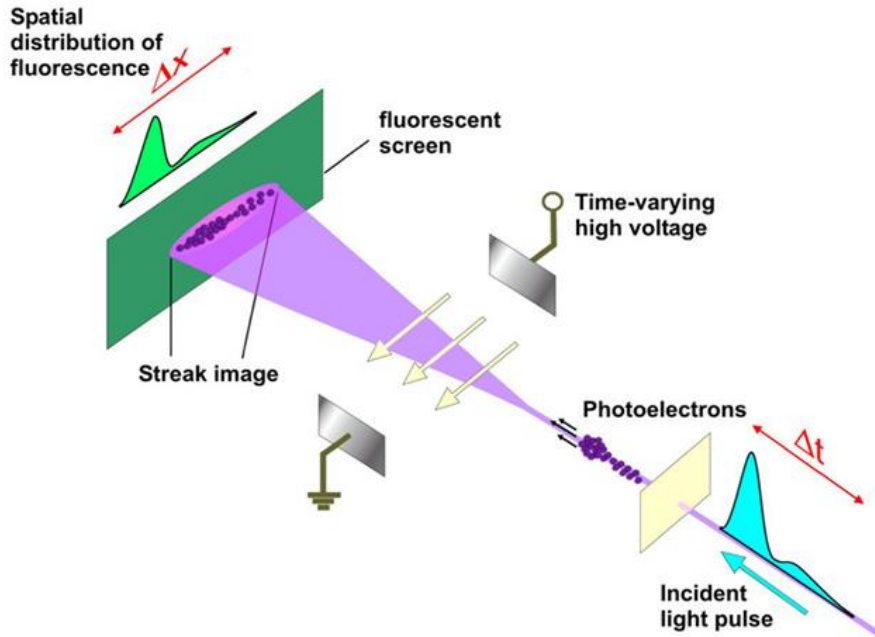
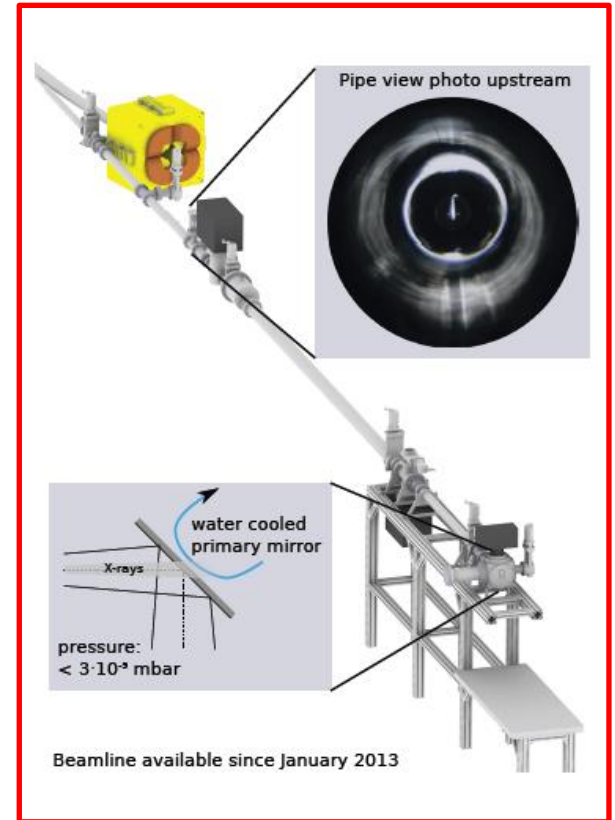
High Resolution Diagnostics

(K. Scheidt: Review of streak cameras for accelerators, Proc. EPAC 2000)

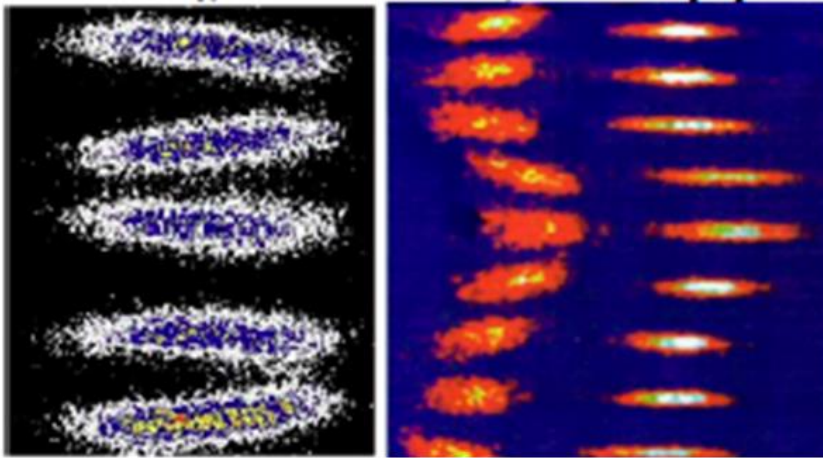
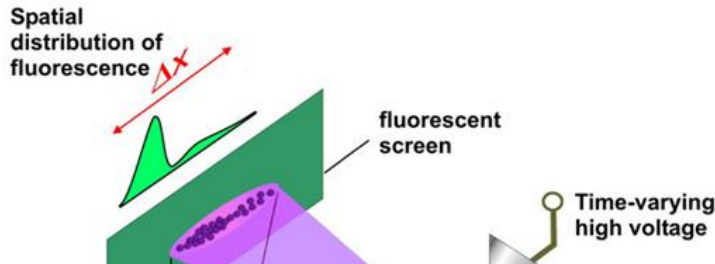
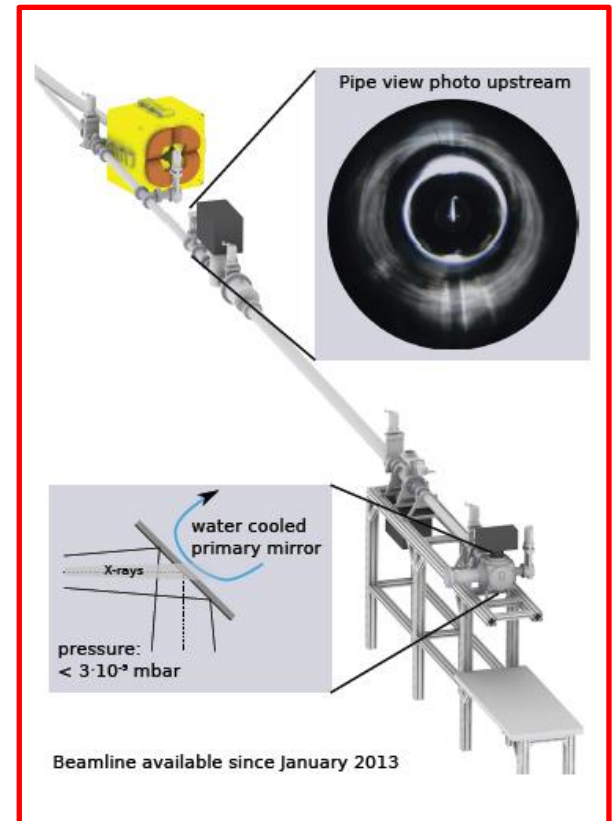
High Resolution Diagnostics

(K. Scheidt: Review of streak cameras for accelerators, Proc. EPAC 2000)

Actual Status:

- SYLI beam line operational since January
 - Streak Camera (ps-resolution) ordered
- Funded by DFG within D.2 of SFB/TR 16!*
- short beam test required end of May!!**

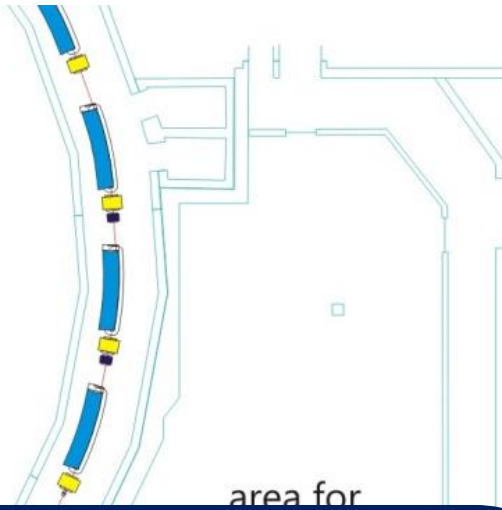
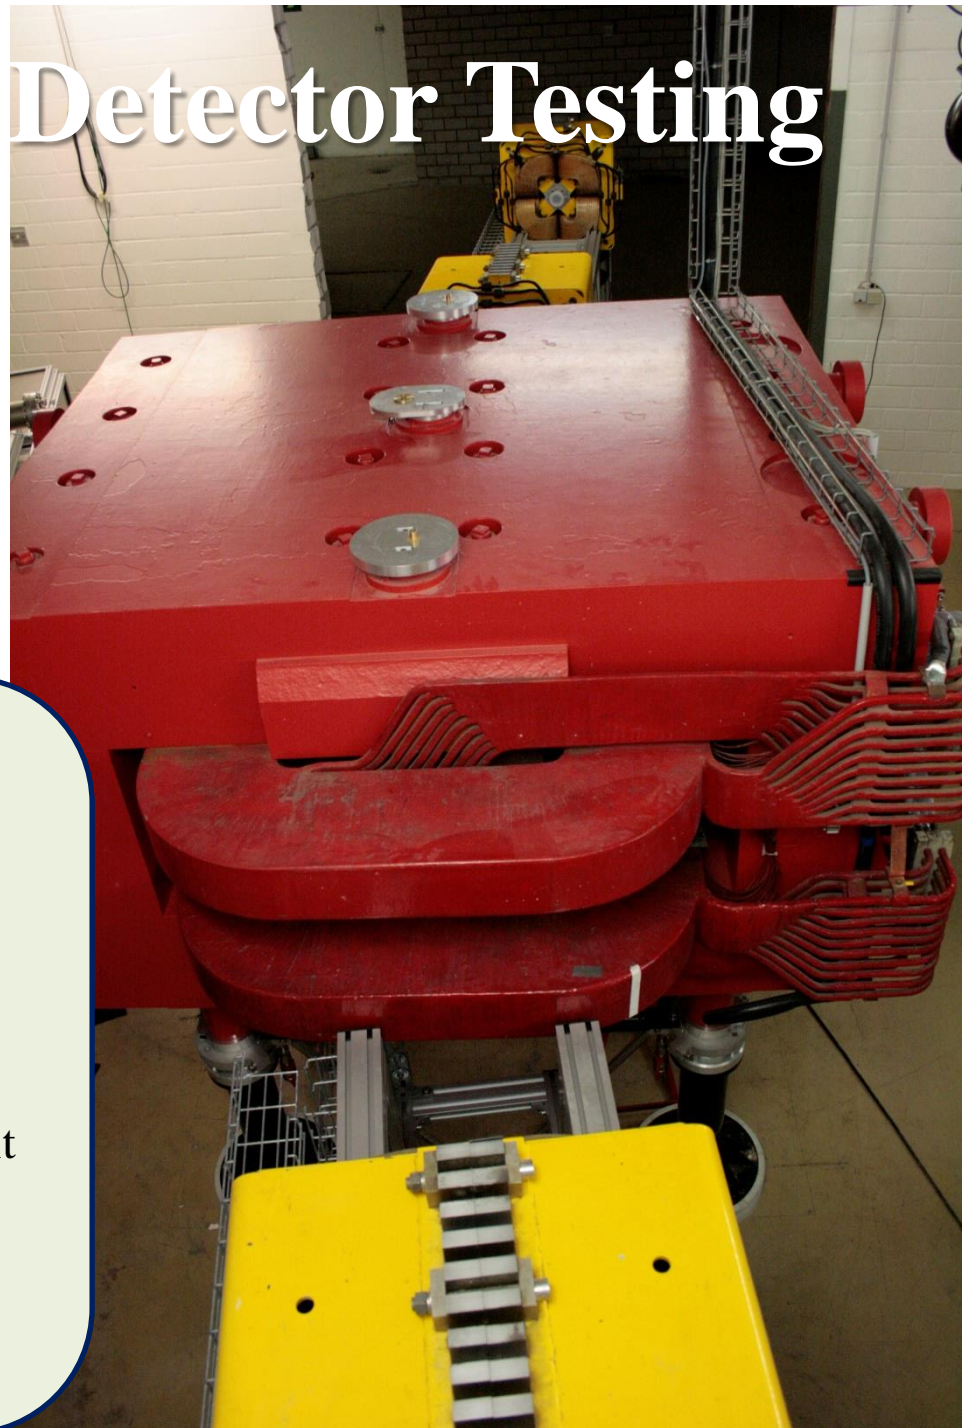
Beam Line for Detector Testing

Actual Status:

Experimental Area:

- magnets and supports in place,
- power cables, water cooling, beam pipes and diagnostics ready for installation
- main PS in the area, some still missing
- problem: beam dump and emergency exit
